SYSTEM SUPPORT DIRECTIVE

ASR9

SSM-ASR9-018

SAFETY MODIFICATION SAFETY ANCHOR BRACKET WORK POSITIONING

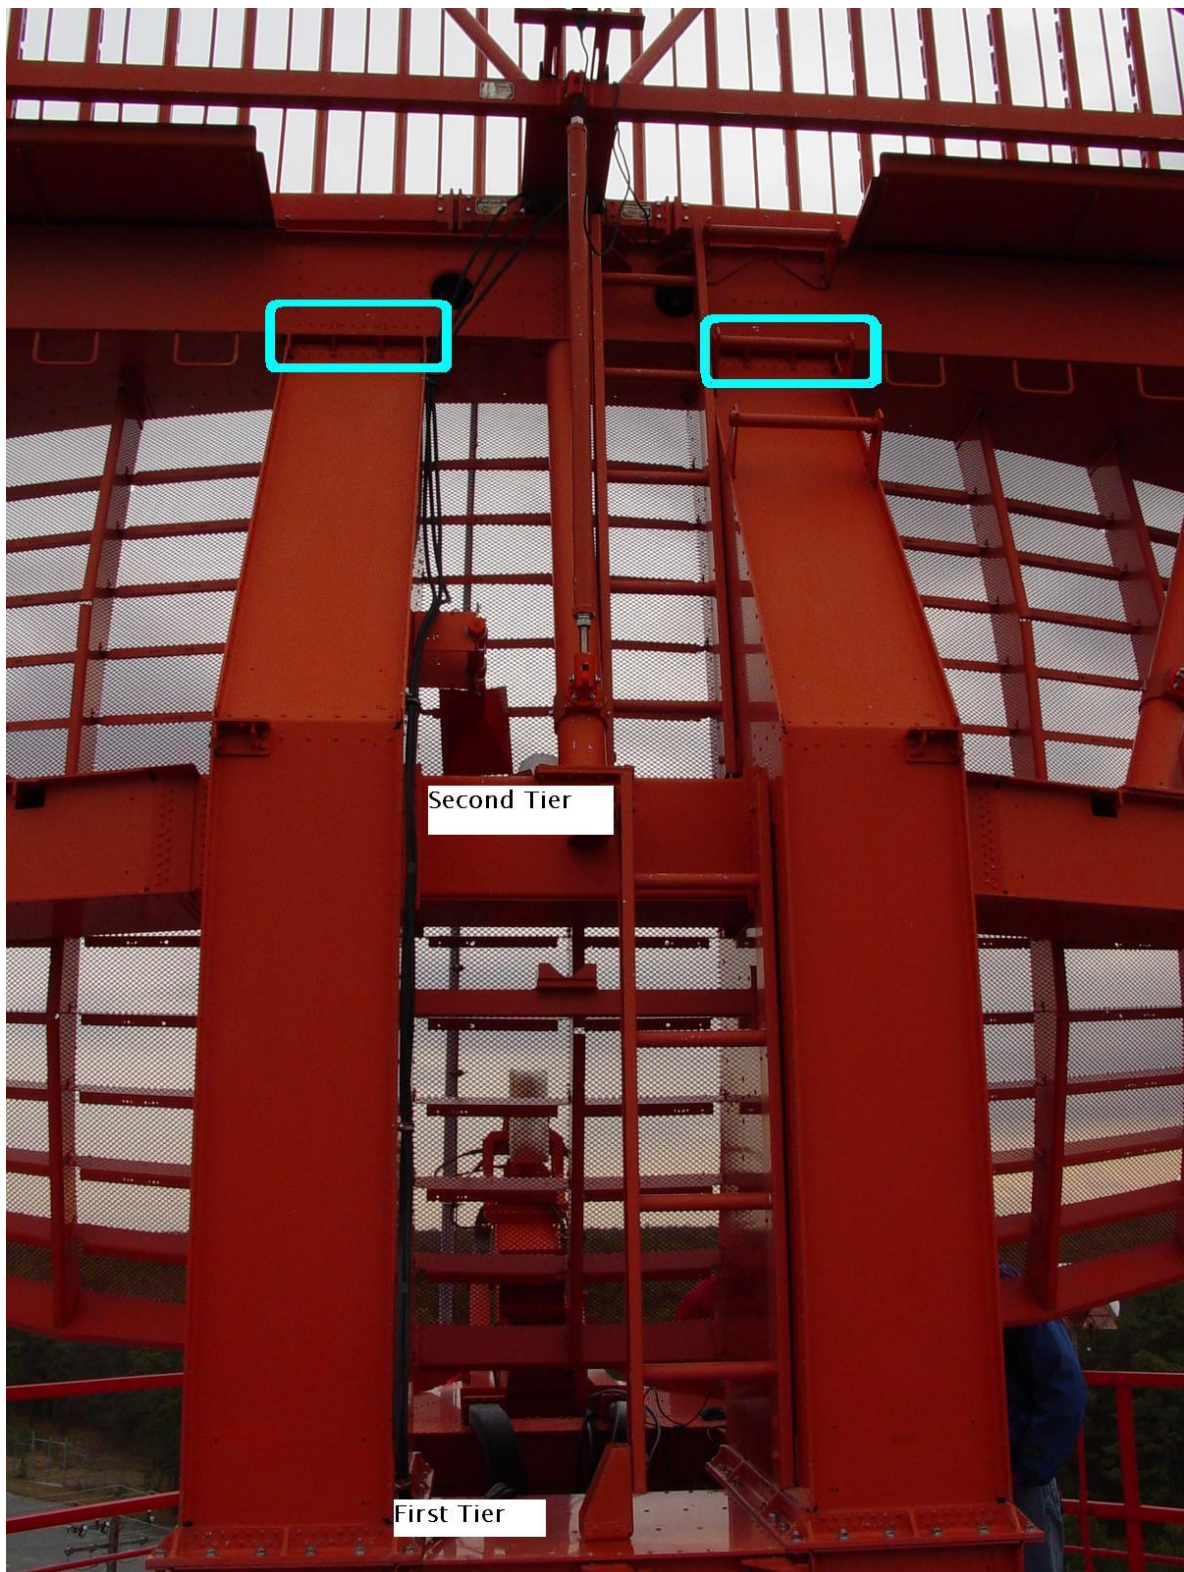
Figure 1. Bracket Positions on the Antenna

- d. Follow OSHA requirements for fall protection, put on safety harness with work positioning cable.
- e. Climb ladder located on the back of the ASR-9 Antenna, to the second tier. (Figure 1)
